Mill Street Corridor Assessment/Cleanup Overview

Former S. Bent Mill Site

Former Garbose Metals Site

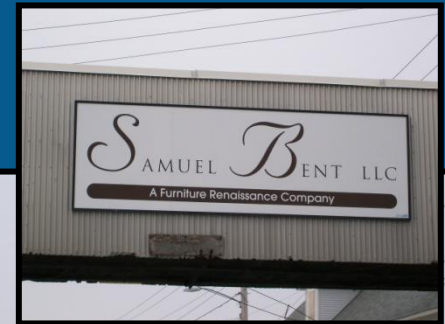
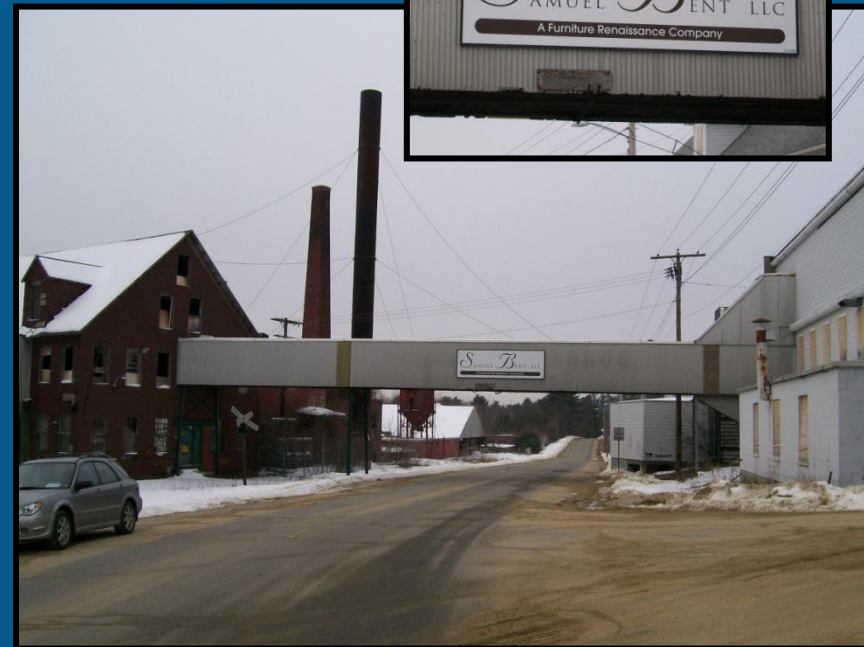
■ Existing Conditions

- 27 acres of land south/north of Mill Street
- Vacant 1.5-story wooden structure remaining (footprint 50,000 feet²) north of roadway

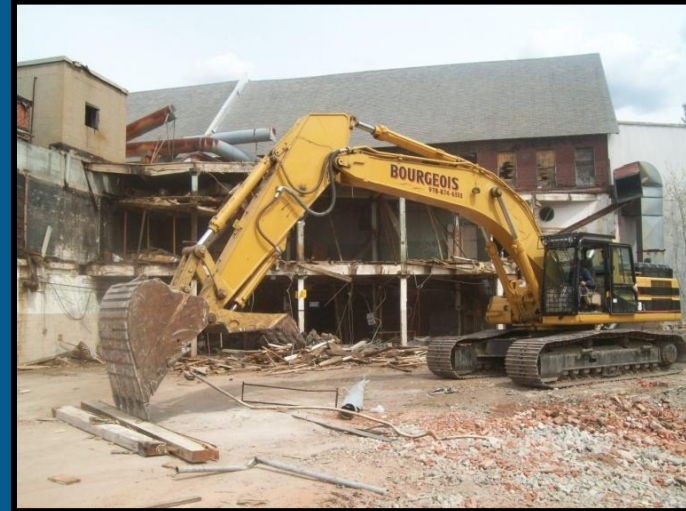
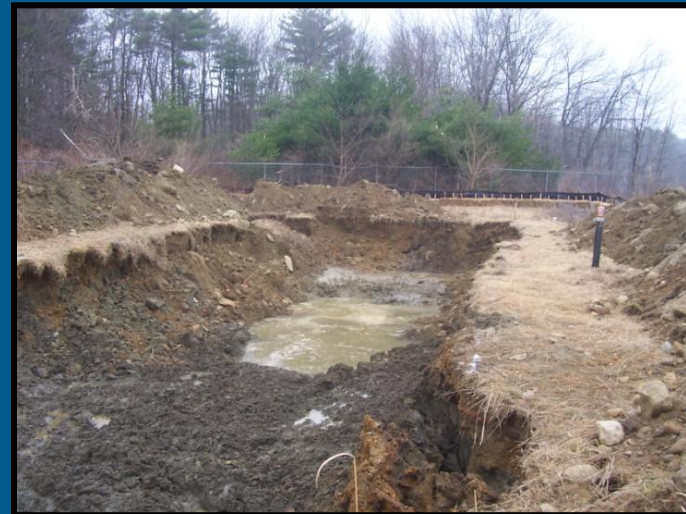
- 3 separate reportable releases (RTNs) identified
- Petroleum impacts to soils; no significant groundwater impacts

■ **Building Demolitions**

- Mill building complex south of Mill Street (two stages)
- Complete building survey of asbestos containing and hazardous materials
- Selected contractor complete abatement, demolitions, and foundations removal (2nd stage)

- 3 release areas cleaned up under Release Abatement Measure Plan
- RTNs closed out without need for deed restriction

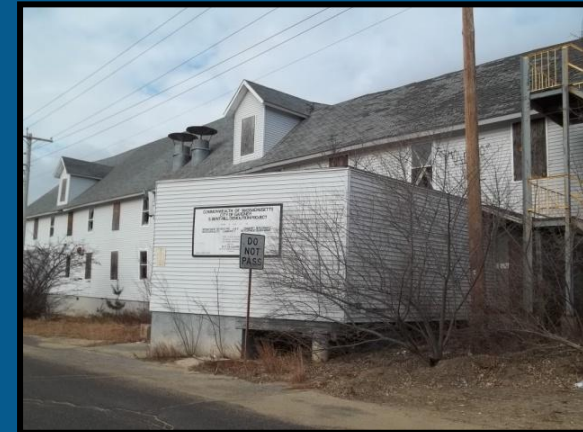
■ Existing Conditions

- 10.6-acres of land
- Abandoned garage and warehouse buildings
- Mostly un-vegetated area where former scrap metals operations occurred
- Resource areas on SW portion of site

■ Site History Overview

- Metal recycling operations circa 1958 to 1999
- Included car crushing operations and dismantling of electrical transformers (oils burned or drained on site)
